Research Report  
KTC-99-5

EVALUATION OF CORRUGATED STEEL PIPE CULVERTS  
KY 55, SHELBY COUNTY

March 1999

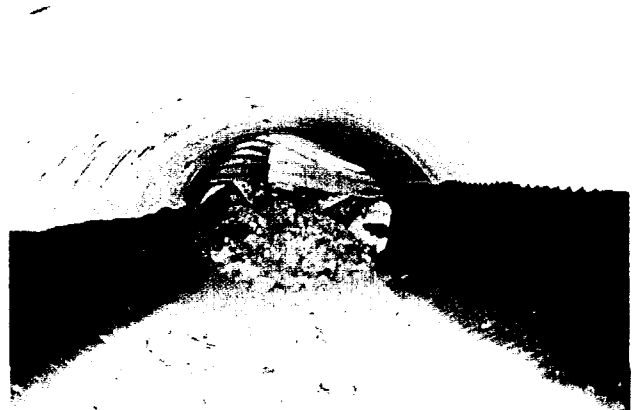
Several random visual inspections were performed throughout the course of the project. During one of the inspections on August 9, 1998, a failure was observed in a pipe arch at Station 531+15 (Figure 1). From conversations with the inspector it is apparent that a pan driver ran over the pipe with less than one foot of fill over the pipe (Figure 2). The failed section of the arch was removed and replaced.

**Figure 1. Failure observed in cross drain at Station 531+15.**

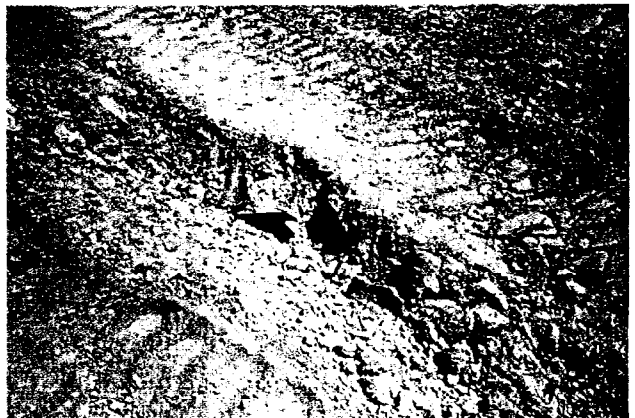
**Figure 2. Top of cross drain damaged by pan at Station 531+15.**

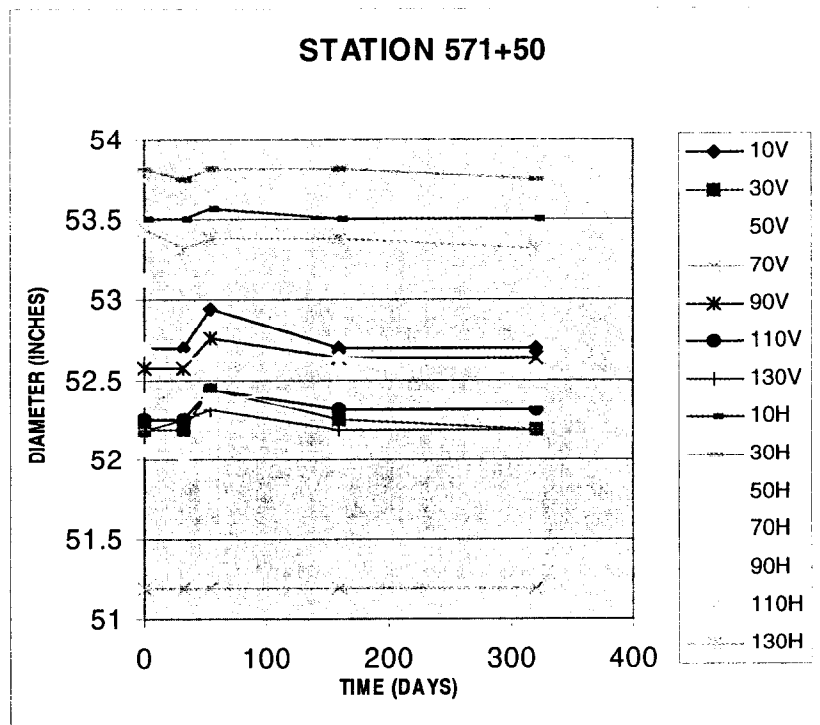
**Figure 5**

Deflection measurements were taken on five cross drain structures. Deflection measurements are shown in Figures 5 through 9. The 0.5 to 1.0-inch of paved invert was not taken into account during the vertical deflection measurements. In four out of five pipes, the maximum deflection has exceeded the design value of five percent. The deflections appear to have stabilized in most of the pipes except for one location in the 60-inch cross drain at Station 701+50. At monitoring point number 87 approximately midway through the structure the pipe had continued to deflect while the remainder of the structure had stabilized. The pipe was monitored in March and April of 1999. In March, the horizontal deflection remained unchanged and the vertical appeared to have continued to move. Approximately one month later (in April) neither the horizontal nor vertical deflections had changed. Currently the pipe has deflected approximately eight percent.
